**Report of Investigations with Recommendations,  
Biological Fouling of the Pressure Relief Drainage System,  
Pablo Canyon Dam, Montana**

**Denise M. Hosler (retired)  
Ecological Research and Investigations Group  
Bureau of Reclamation  
United States Department of the Interior**

**September 2001**

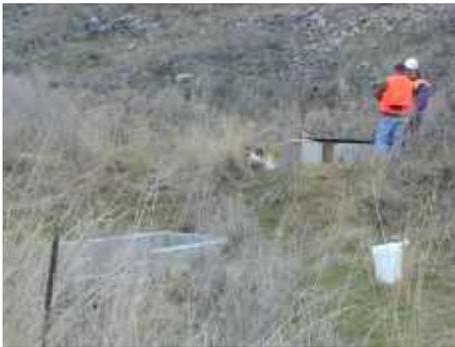
Figure 1. Manhole and weir

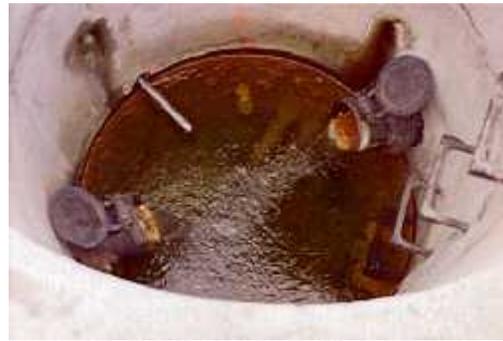
Figure 2. Manhole Drains The larger pipes with caps are the toe drains. Accumulated biofilm in the toe drains is visible.

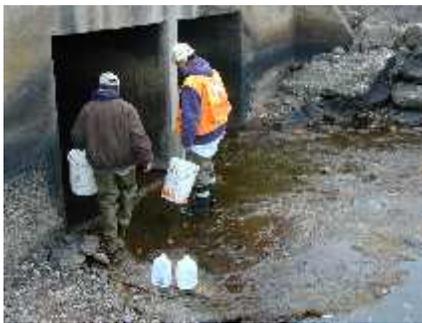
Figure 3. Outlet Works Entrance to the Outlet works, where the seep drains are located.

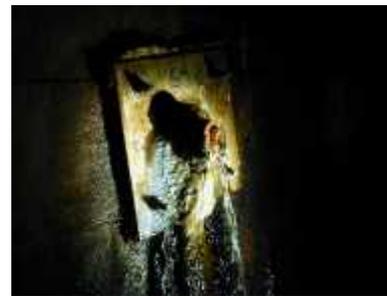
Figure 4. Seep Drains S-4 which is located in the southern Outlet Works Tunnel.

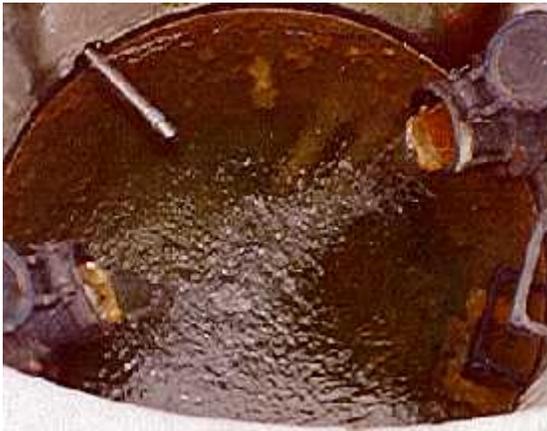
Several of the manholes and associated toe drains and drain wells exhibited visible evidence of biofouling (Appendix 2). Toe drains (in particular those entering manholes ( MH-10, -11, -12, -13 and -14) had light tan to black biofouling at or below the water level in the drain. The sump at MH-14 was heavily populated by soft, filamentous biofouling lining the walls, submerged surfaces, and as globules in the water. Additionally, similar growth was visible in the MH 14 discharge weir, growing on the weir plate (Figures 5 and 6). Weep drains also revealed evidence of microbial growth, with the occurrence of dark tan, black, and white biofilm. Aside from the visual observation of biofilm, the chemical data indicates that several microbial processes are effecting the chemical reactions that contribute to the sediments in the drain system.

Figure 5. Manhole 14 (Above)  
Sump heavily populated by filamentous biofilm.

Action Item: Using preliminary model results, it is recommended that some pilot drain and weep cleaning programs be implemented at the site. The initial program would start with MH 14 and a second impacted system, such as MH 13 or MH 10 to demonstrate program efficacy in differing geochemical environments.

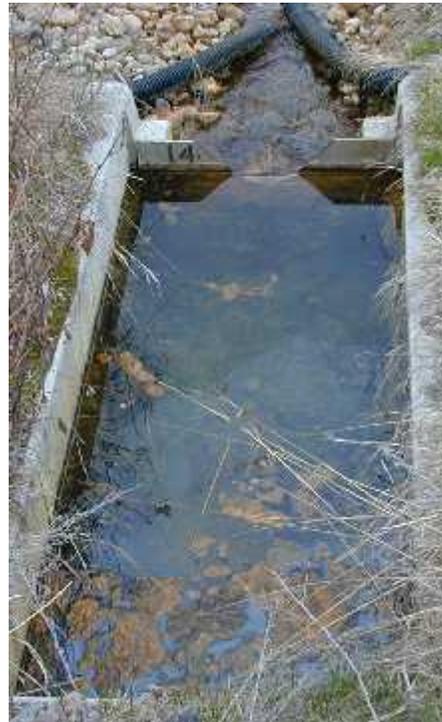
Figure 6. Manhole 14 weir (Right)  
Biofilm evident in weir and downstream.

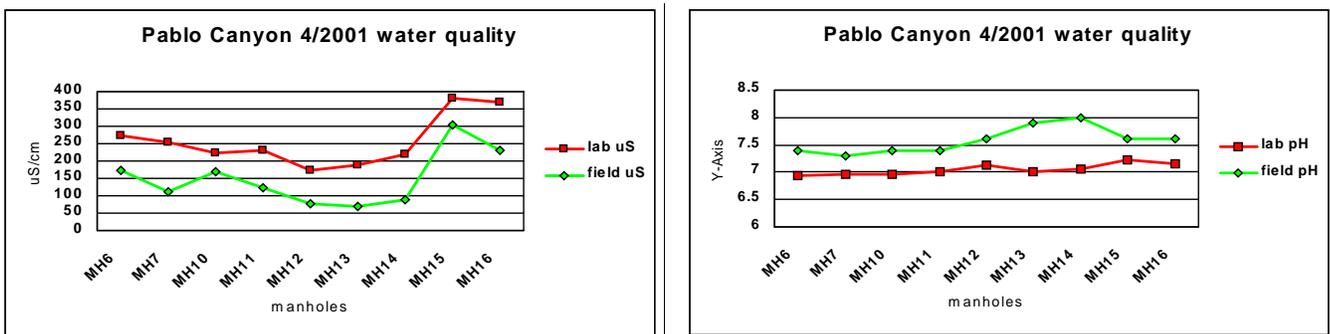
Figure 7. Graphs of Field and Laboratory Conductivity and pH Measurements

The general water chemistry analyses revealed suitable conditions for long-term microbial growth, that is, a neutral pH, with abundant dissolved oxygen, total organic carbon, nitrogen, and phosphorus available for metabolic processes. Conductivity ( $\mu\text{S}$ ) and pH measurements taken in the field and again in the lab differ, conductivity going up in the lab and pH dropping (Figure 7). Both instrumentation differences and microbial activity within the samples may account for these variations.

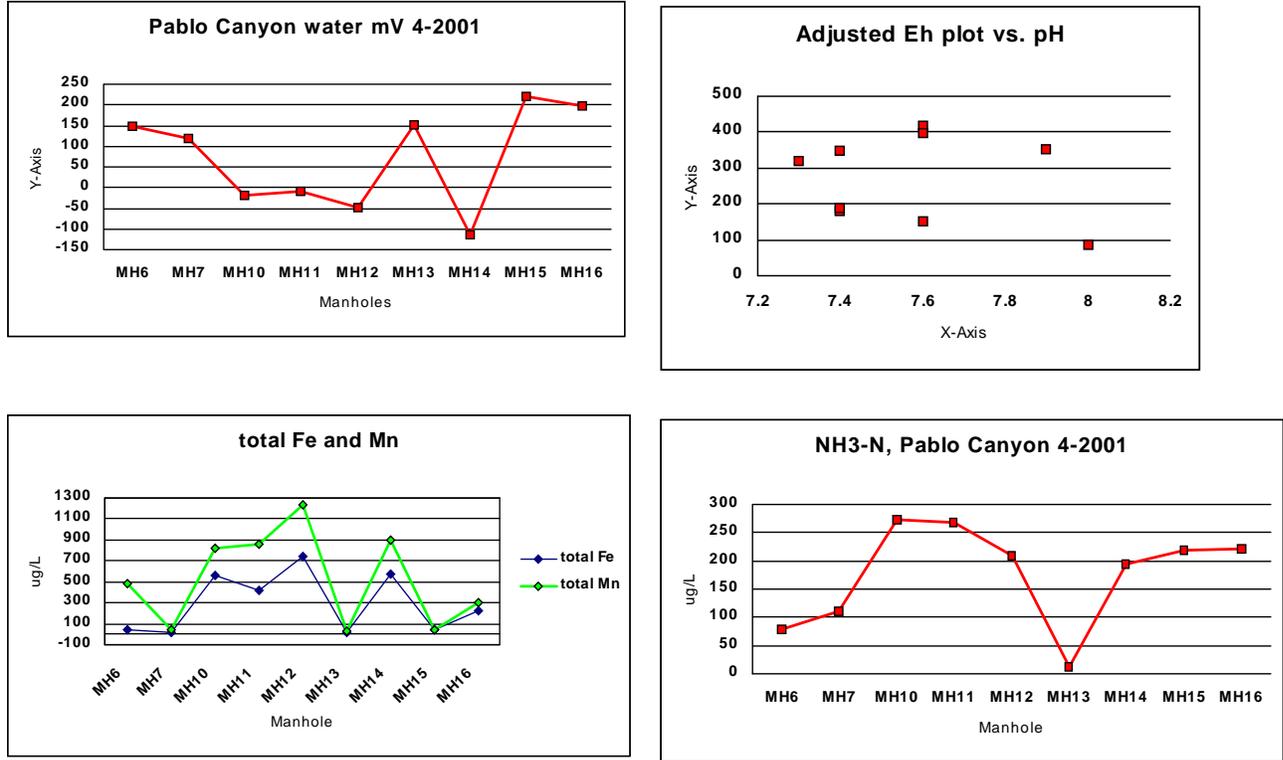
Figure 8. Graphs of Field and Laboratory Parameters

The redox measurement in the field reported as bulk mVs, was adjusted to Eh (in reference to  $\text{H}^+$ ) and plotted vs. pH. The Eh is generally in the range of  $\text{Fe}(\text{OH})_3$  deposition (Hem, 1985). The  $\text{Fe}^{3+}$  (total Fe -  $\text{Fe}^{2+}$ ) was 66-99 % of total Fe in samples evaluated, indicating ample  $\text{Fe}^{3+}$

availability for deposition. Additionally, the presence of Mn-containing deposits suggests that microbial deposition of MnIV oxides is occurring, as Eh-pH values are outside the range of autooxidation of Mn oxide deposition and Mn<sup>2+</sup> was the predominant Mn form in water samples except in MH-7 and MH-16.

- High concentrations of Fe and Mn generally occurred in samples from locations with low mV readings in water (see graph). This is possibly due to Fe and Mn reduction, as there does not seem to be any lack of Fe and Mn oxide deposition.
- All samples except MH 15 basin had Mn values greater than Fe values, indicating active Mn reduction is occurring.
- High Fe and Mn also appear to match up to higher NH<sub>3</sub>-N levels.
- NH<sub>3</sub>-N parallels with lower mV values and reactivity rate (see chart, with MH 10, MH 11, and MH 14 NH<sub>3</sub>-N elevated).
- MH 14 water (all three clear water samples), which exhibited extensive biofouling had among the lowest in organic P, evidence of microbial uptake of P.
- Among solids, ICP/ES indicated that Mn was greater than Fe in seep biofouling solids samples, the reverse of manhole solids. This suggests variety in microbial deposition.
